Subbasin Profiles and Synthesis

Mattole Estuary

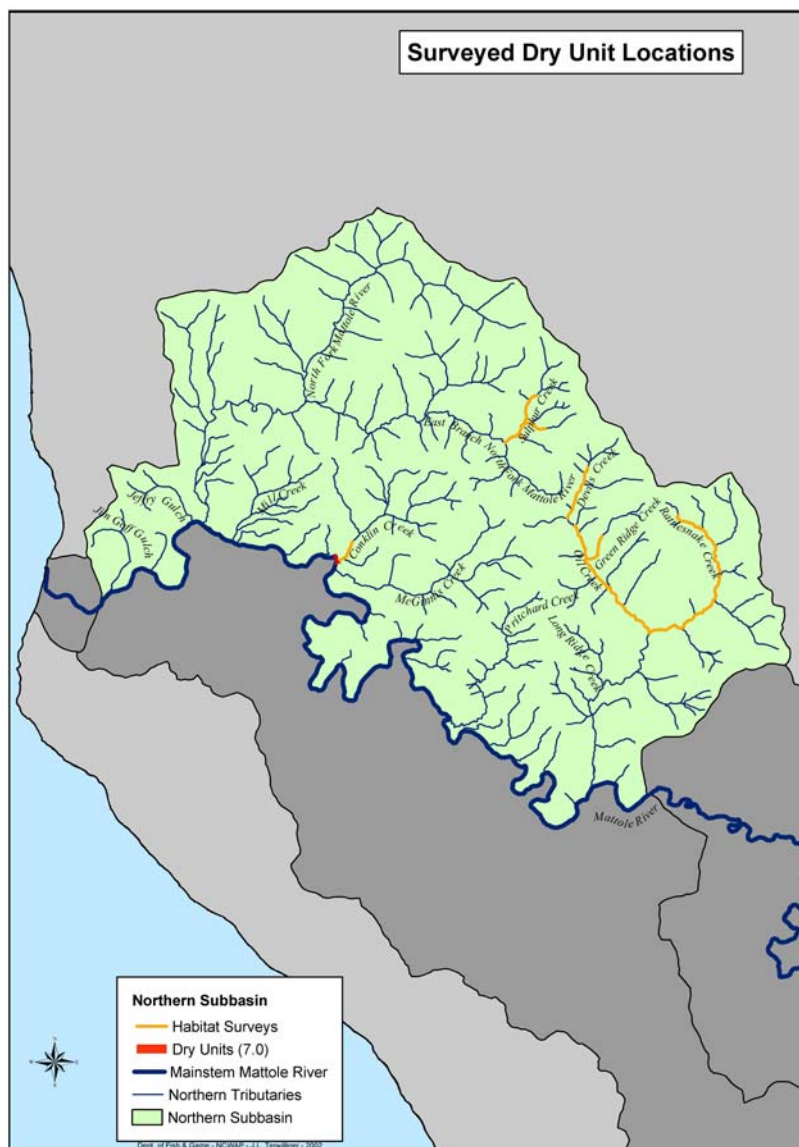
Figure 73. Mapped dry channels in the Northern Subbasin.

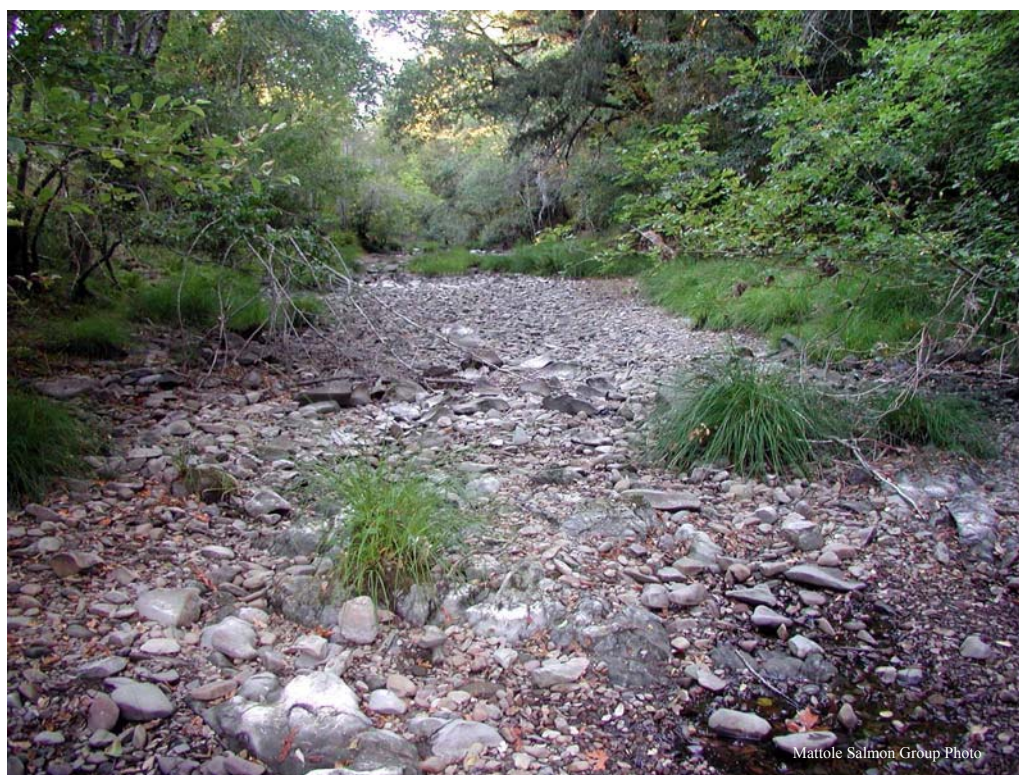
Figure 111. The Mattole River at Thorn Junction on September 18, 2002.

In addition to stream inventory data on dry channel, interviews with local residents, newspaper articles, and observations by NCRWQCB, the National Marine Fisheries Service (NMFS), and CDFG have shown that de-watering can be a problem in the Southern Subbasin (Figure 111, Figure 112). An October 2002 article

in the southern Humboldt County newspaper *The Independent*, reports that the Mattole River was reduced to a bare gravel bar with scattered, disconnected pools for 3,000 feet at Shadowbrook Bridge downstream of Whitethorn. Some long-term local residents claimed that Mattole River water levels were the lowest they had ever seen. Causes of the de-watering were attributed to a combination of drought and water use, especially for agricultural operations by Mattole Basin residents.

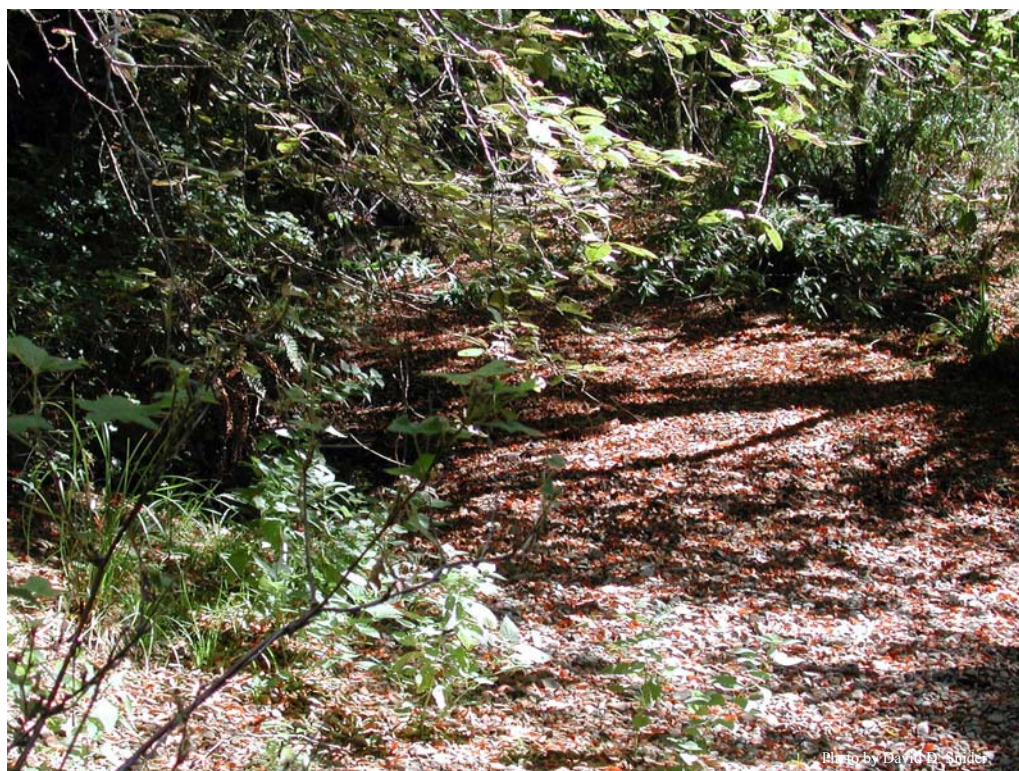
Figure 112. The Mattole River Headwaters near Mill Creek (RM 56.2) on September 18, 2002.

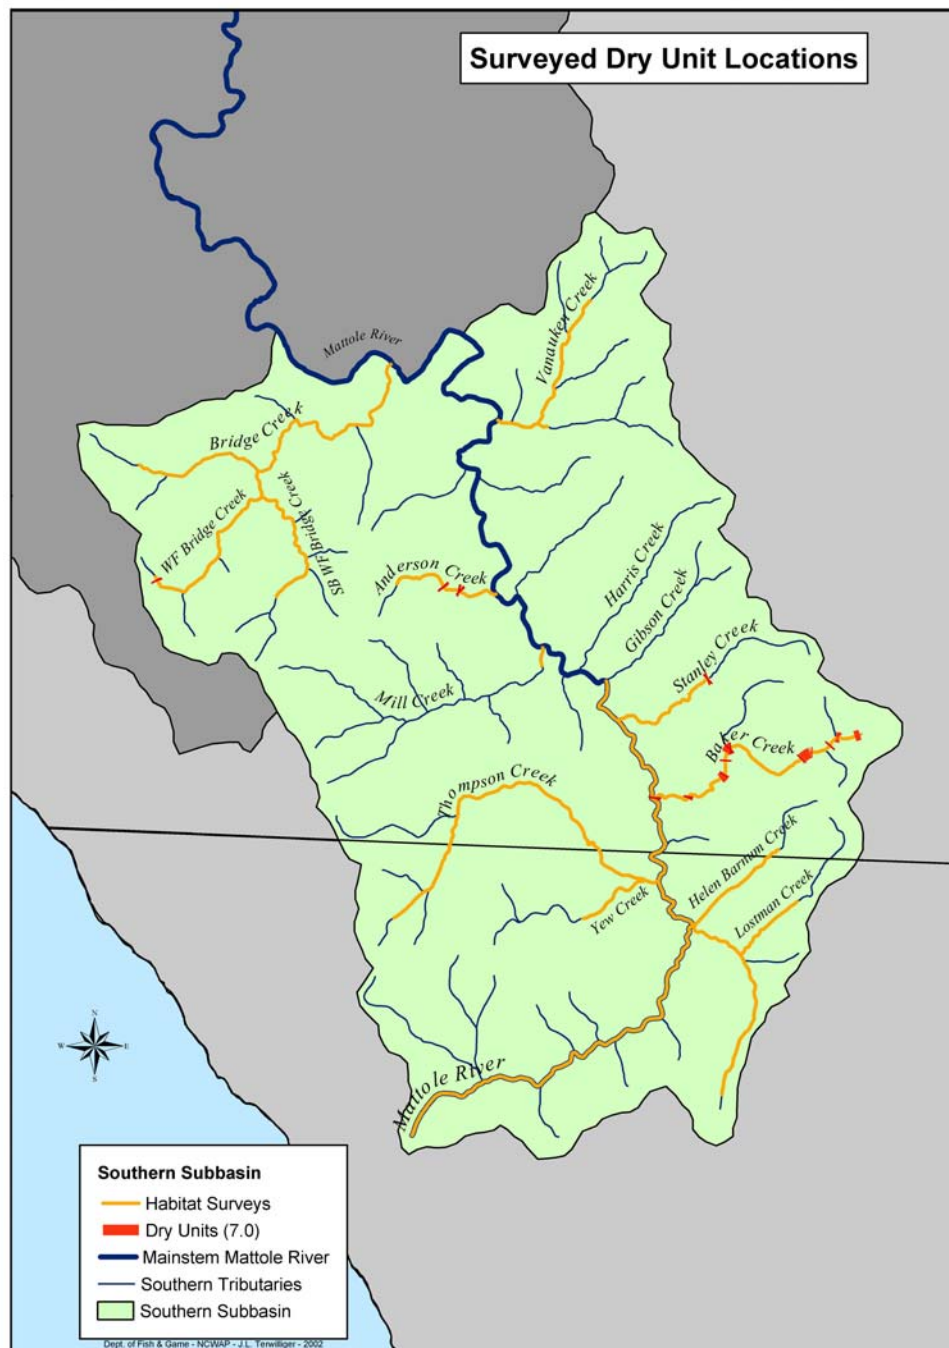
Figure 113. Mapped dry channels in the Southern Subbasin.

Dry channel disrupts the ability of juvenile salmonids to move freely throughout stream systems. Juvenile salmonids need well-connected streams to allow free movement to find food, escape from high water temperatures, escape from predation, and migrate out of their stream of origin. The amount of dry channel reported in surveyed stream reaches in the Southern Subbasin is 1.2% of the total length of streams surveyed. Dry channel was found in four streams (Table 116, Figure 113). Dry habitat units occurred in the middle reaches of two tributaries, and at the upper limit of anadromy in three tributaries. Dry channel in the middle reaches of a stream disrupts the ability of juvenile salmonids to forage and escape predation while dry channel in the upper reaches of a stream indicates the end of anadromy.

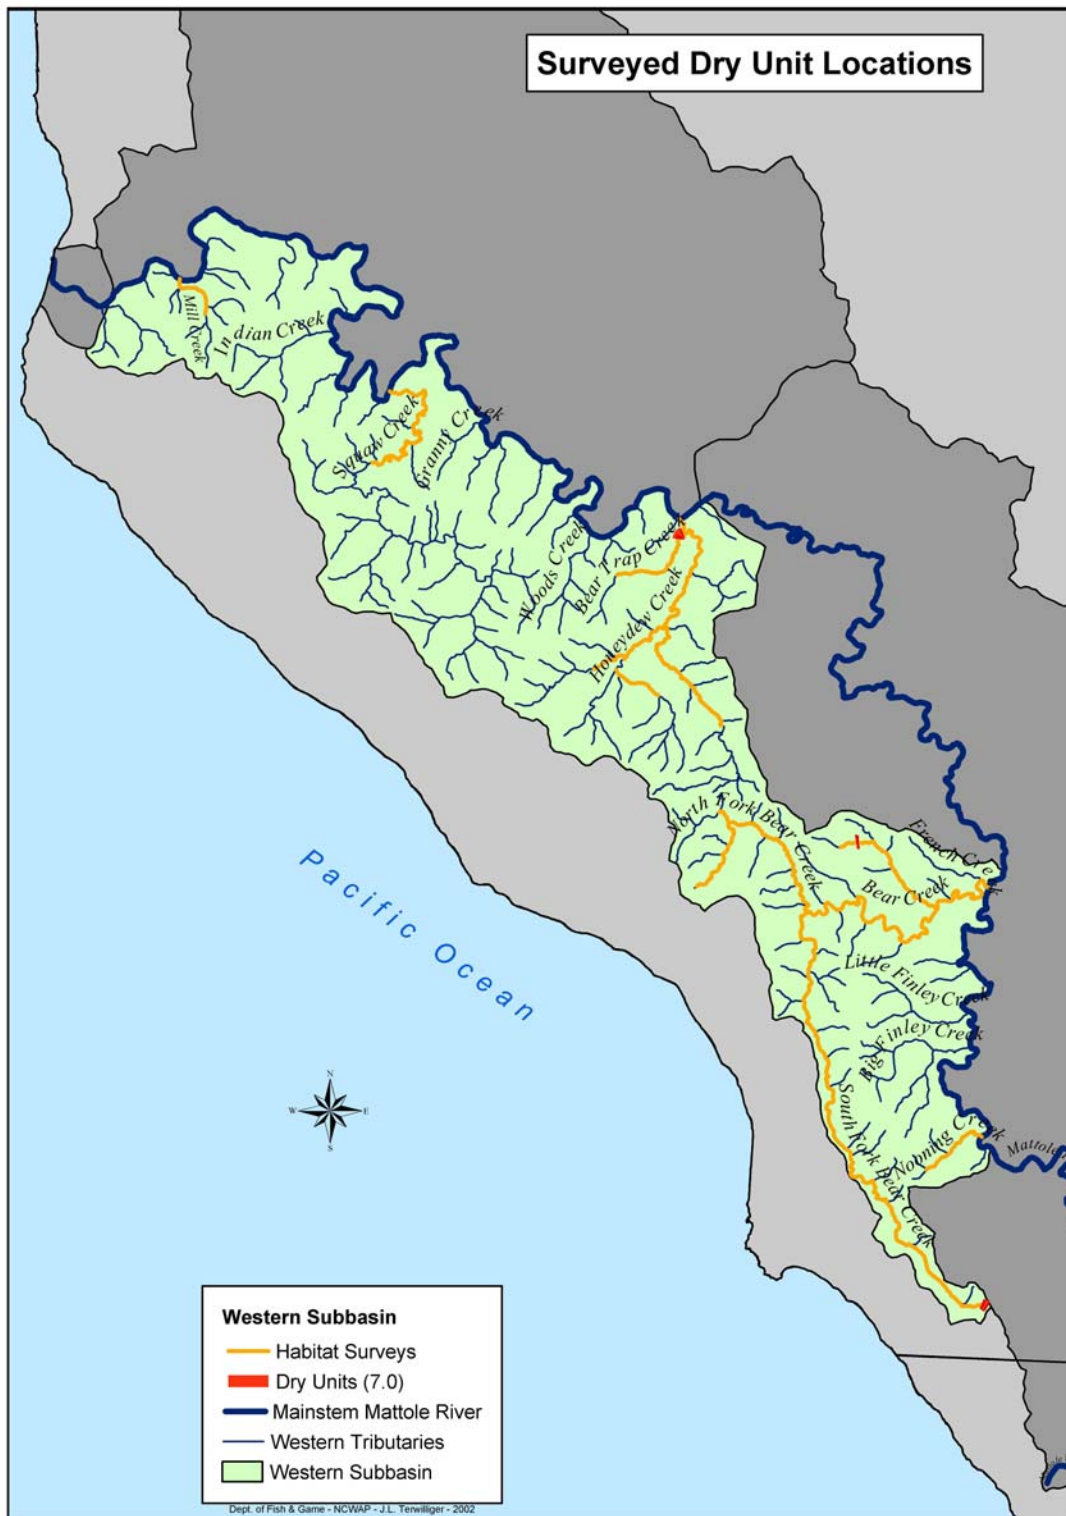
Figure 132. Mapped dry channels of the Western Subbasin.

Dry channel disrupts the ability of juvenile salmonids to move freely throughout stream systems. Juvenile salmonids need well-connected streams to allow free movement to find food, escape from high water temperatures, escape from predation, and migrate out of their stream of origin. The amount of dry channel reported in surveyed stream reaches in the Western Subbasin is 0.04% of the total length of streams surveyed. Dry channel was found in three streams (Table 143, Figure 132). Dry habitat units occurred near the mouth of Bear Trap Creek and the South Fork of Big Finley Creek, in the middle reaches of Jewett Creek, and at the upper limit of anadromy in the South Fork of Bear Creek. Dry channel at the mouth of a tributary disconnects that tributary from the mainstem Mattole River, which can disrupt the ability of juvenile salmonids to access tributary thermal refugia in the summer. Dry channel in the middle reaches of a stream disrupts the ability of juvenile salmonids to forage and escape predation. Lastly, dry channel in the upper reaches of a stream indicates the end of anadromy.
